Research Report 1524

# MANPRINT Evaluation: AN/TRC-170 Digital Troposcatter Radio System

Gregory S. Krohn and Samuel E. Bowser  
Essex Corporation

June 1989

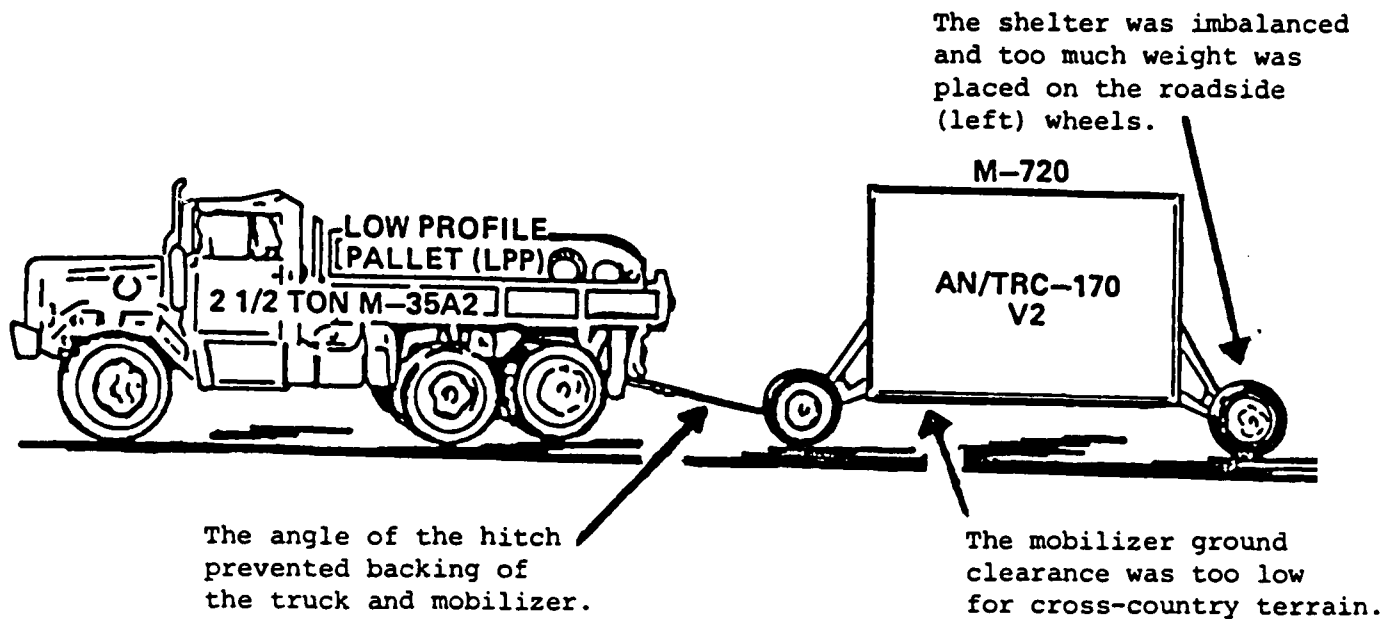
Figure 8. The M-720 mobilizer carrying the S-665 shelter. (The actual configuration of the mobilizer differed slightly from the graphic representation.)

- c. The mobilizer cannot be driven in reverse when towed due to the angle of the trailer tongue when hitched. The trailer tongue was raised approximately 2.5 ft at a 35-deg angle when it was attached to the hitch of the 2.5-ton truck. Backing the mobilizer would result in equipment damage to the hitch or tongue as forces would cause the tongue to fold over.

Implications: The mobilizer may not be suited for cross-country use where rough terrain will be traversed and backing in reverse is a frequent maneuver. Equipment such as the trailer tongue and wheel lugs may be damaged. Crewmen may be injured as they attempt to manually position the mobilizer.

Data: There were six mobilizers (M-720) used for the test; four were dead-lined due to sheared off wheel lug posts on the roadside wheels. Five of the six mobilizers have some damage related to cross-country travel and the weight of the trailer. Crewmen were interviewed and 94% stated that the mobilizer could not be moved manually by the present crews without additional help. The data collectors (97%) and test directorate personnel (92%) agreed. The supervisory personnel stated that a minimum of 5 persons were required to do this task.

Potential Solutions: The internal shelter configuration had all the electronic components positioned on the roadside of the mobilizer. Perhaps the electronic components could be repositioned on both sides of the mobilizer in order to balance the load. However, the only way to avoid exceeding the weight capacity of the mobilizer may be to use a larger-capacity mobilizer.

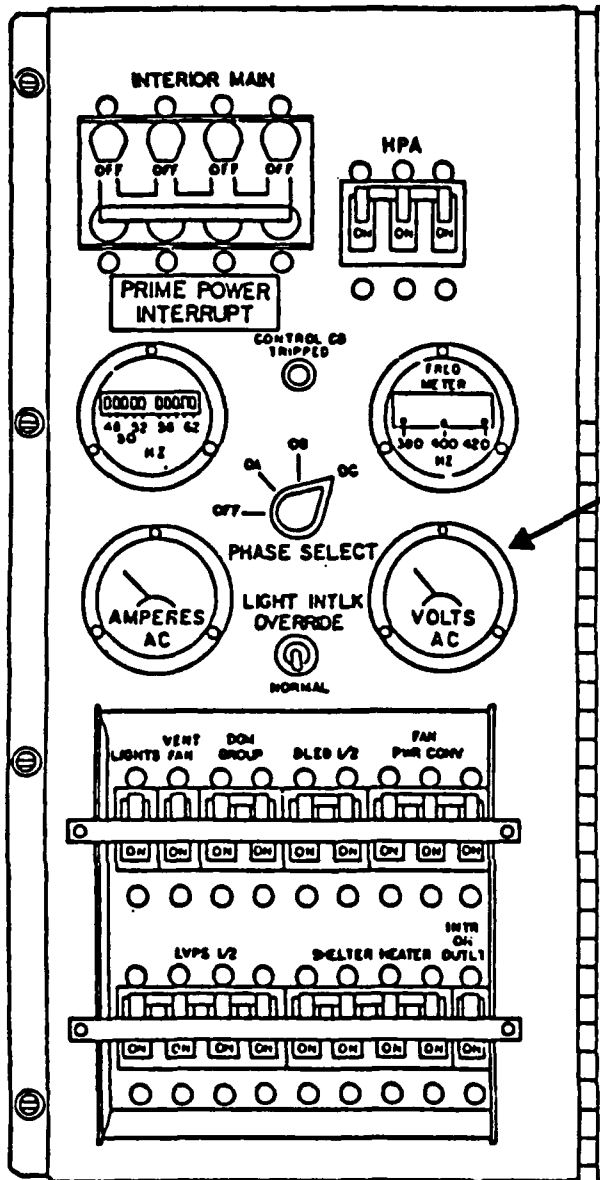
Figure 9. The main power panel in the V3 shelter.

- a. The generators cannot be switched from one to the other without shutting down the V3 system. The generators need to be switched when fuel is emptied or repairs are required. Once the V3 is shut down, a period of 10 to 15 minutes is required for system warm-up before radio transmissions can be resumed.
- b. Figure 9 shows the V3 main power panel. The generators do not have a built-in capability to adjust for power load variations. When power load variations occur, the operator must see the variation on the power panel voltage meter in the V3 shelter or on the generator and then adjust the generator. Power load variations occur when components in the V3 shelter are turned on or off.

Implications: Interruptions to the radio transmissions for generator switch-over occurred every 6 hrs. Unexpected shutdown for generator failures resulted in lost transmissions. Failure to adjust the generators for power load variations may result in a generator shutdown.

The only indication the crewman had of a power load variation was in the shift of the voltage meter needle.

Potential Solutions: Provide the generators with switching capability that provides continuous power without power fluctuations. The generators should be able to automatically adjust for load variations.

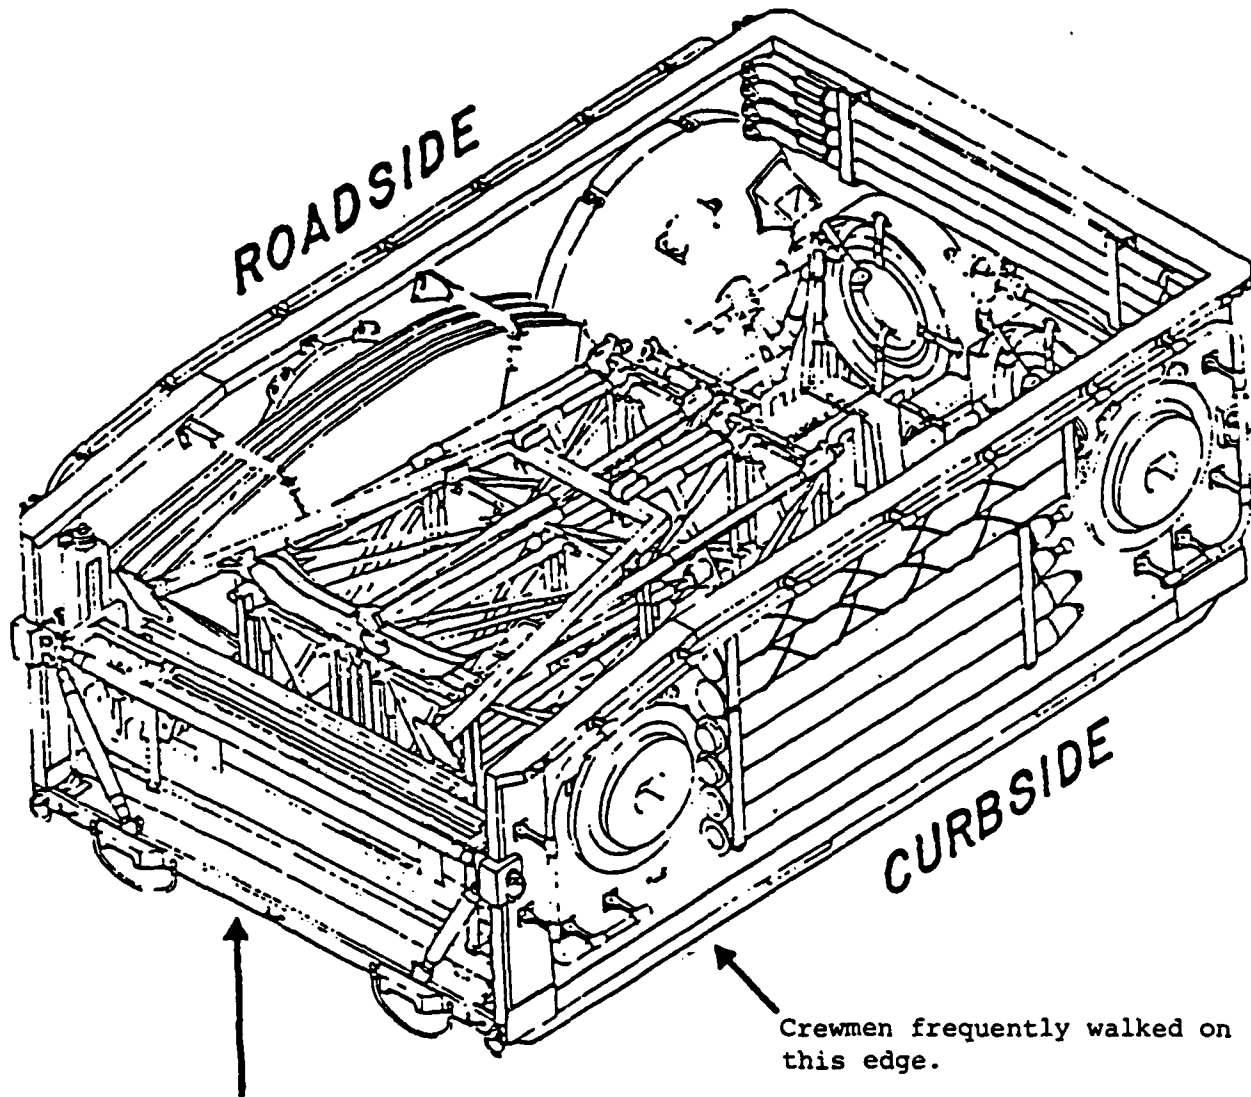
Figure 10. The low-profile pallet that was mounted on a 2.5-ton truck and covered for transport.

Description of the Problem: Figure 10 shows the low-profile pallet and its contents. The loading and unloading of the low-profile pallet for the V2 system (9.5 ft) antenna is unsafe to perform by three crewmen (AN/TRC-170 V2 crew size). The weights that must be lifted and carried exceed MIL-STD-1472C maximums for three soldiers. The unit (Heavy Tropo Company) does not have other personnel available (TO&E) to support the crews in the field to assist in lifting material. The system can not be set up with a two-man crew making the system un-emplacable if any crew member is injured or otherwise unavailable. The units may set up in isolated locations and other personnel may not be readily available.

Implications: The crews may suffer injuries such as back strain, muscle strain, contusions, abrasions, or broken bones. The AN/TRC-170(V2) may not be able to complete its mission.

Data: Seventy percent (70%) of the operators reported that it was difficult for three crewmen to lift equipment when loading and unloading the low-profile pallet.

The pallet was approximately five feet above the ground when mounted on the truck bed.

Potential Solutions: The crew size could be increased by the addition of a maintainer (29M or 29S) to add to the number of persons available for loading or unloading. The procedures for the truss assembly might be modified to reduce the weight lifted by crewmen when disassembling the truss on the pallet.

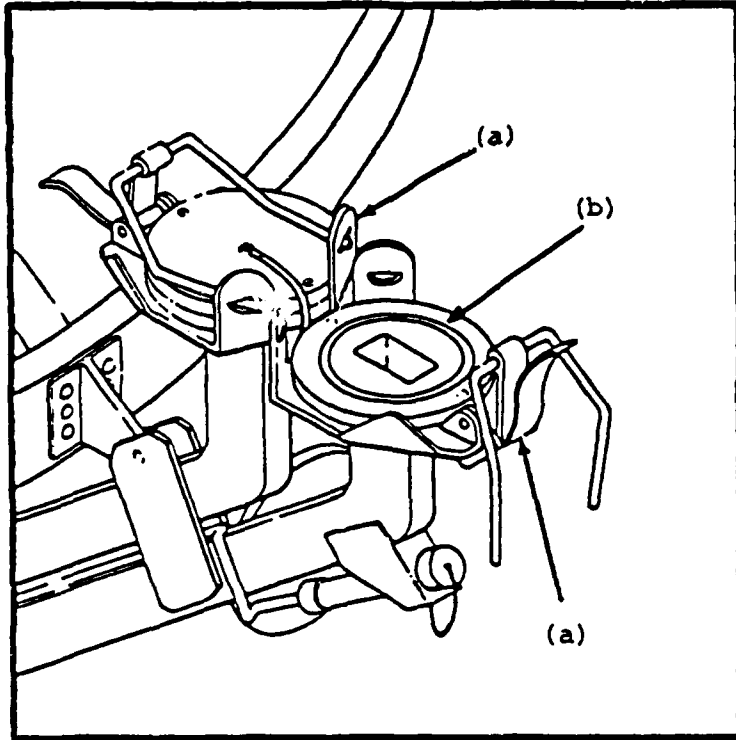
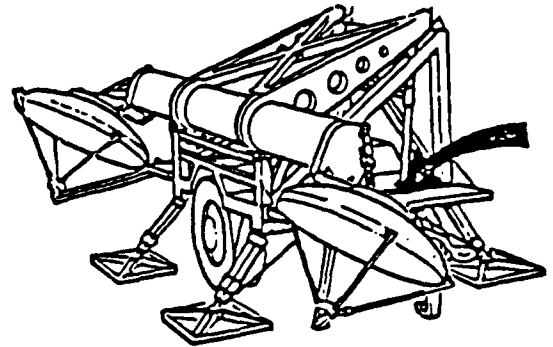
- a. The male plug alignment and signal pins bend, loosen, and fall out.
- b. The male plug O-ring forming the moisture seal falls out making alignment difficult and risking loss of the O-ring. Figure 11 shows the location of the O-ring and latch device.
- c. The latch securing the male plug to the female socket was difficult to manipulate and had to be forcibly closed. The latch could not be closed by crewmen wearing MOPP NBC gloves.
- d. The protective transport containers for the waveguides used on the V2 system were attached to the pallet. The waveguides had to be carried by crewmen from the pallet to the antenna. The exposed waveguides were often stepped on or collided with objects. Figure 12 shows the protective container, while Figure 13 shows the position of the waveguides when laid out on the ground.

Implications: Several factors contributed to damaging of the waveguides. Damaged waveguides will prevent transmission. Additional replacement waveguides will have to be supplied.

Data: Two-thirds (12) of the waveguides were damaged and unusable at mid-test.

Figure 11. The waveguide latches (a) that were difficult to close and the O-ring (b) that fell out.

Potential Solutions: The waveguides should be durable enough for the field environment in which they will be used. Operator training should address the sources and prevention of waveguide damage, especially if the design of the waveguides remains unchanged. Two soldiers, rather than one, should be used to support the waveguide when attaching or detaching it to the antenna in order to keep it evenly supported.

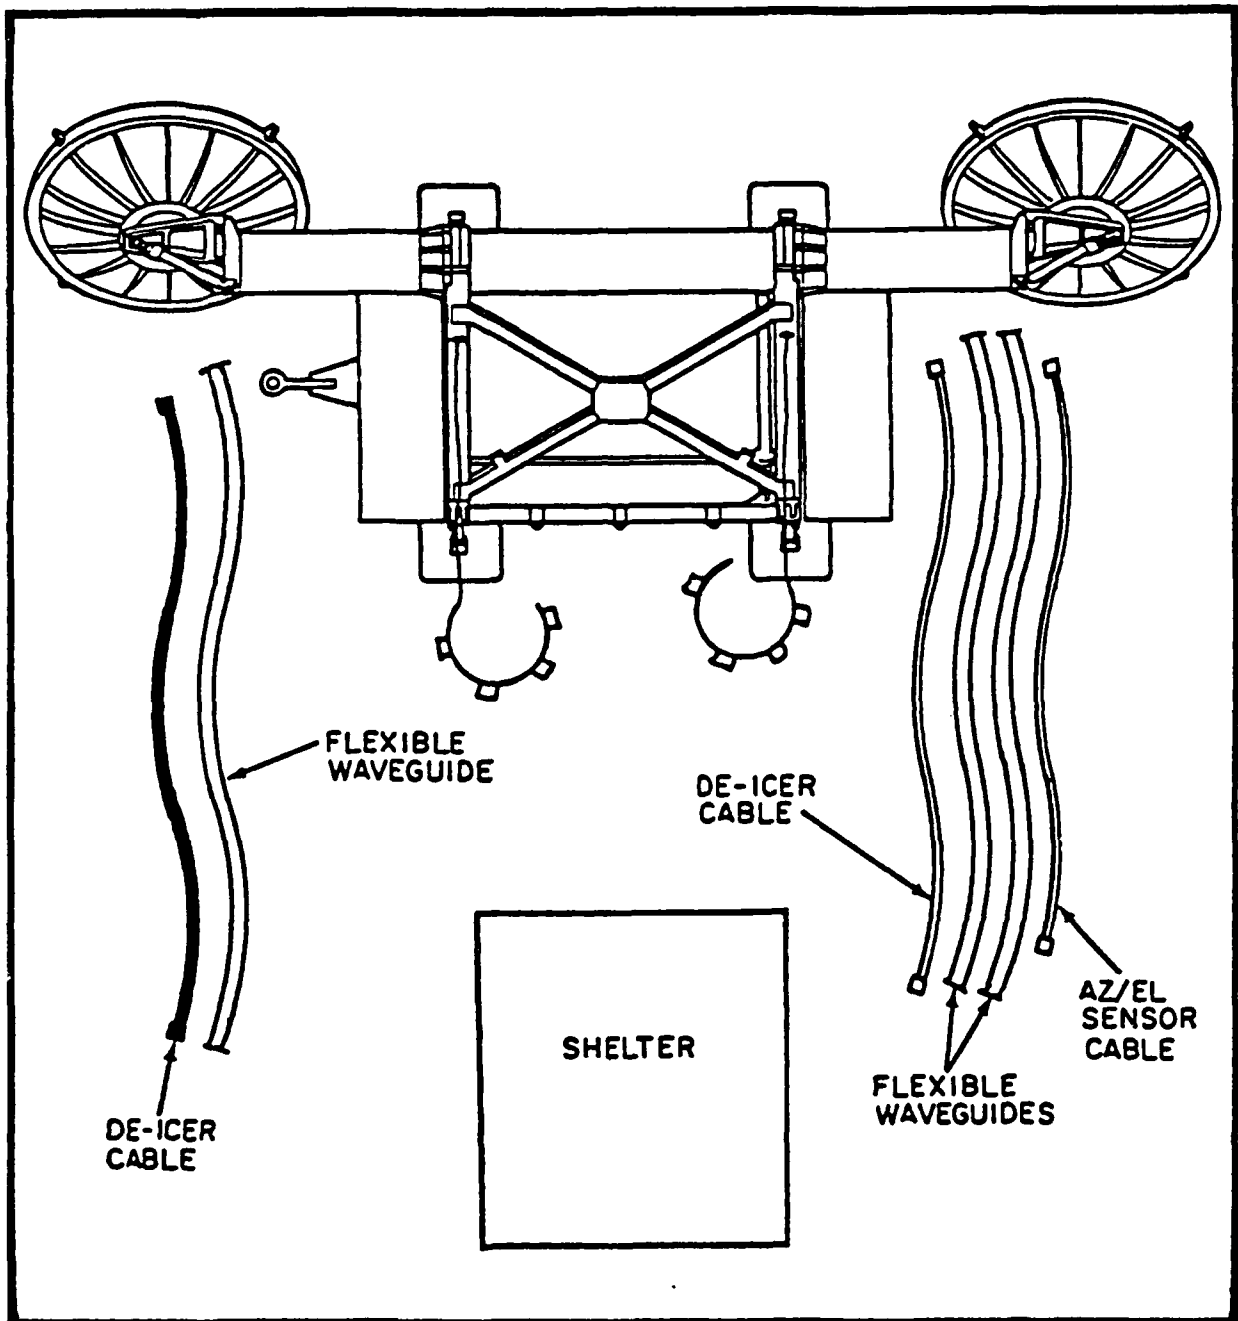
Figure 13. The waveguides and other cables laid out on the ground prior to installation.

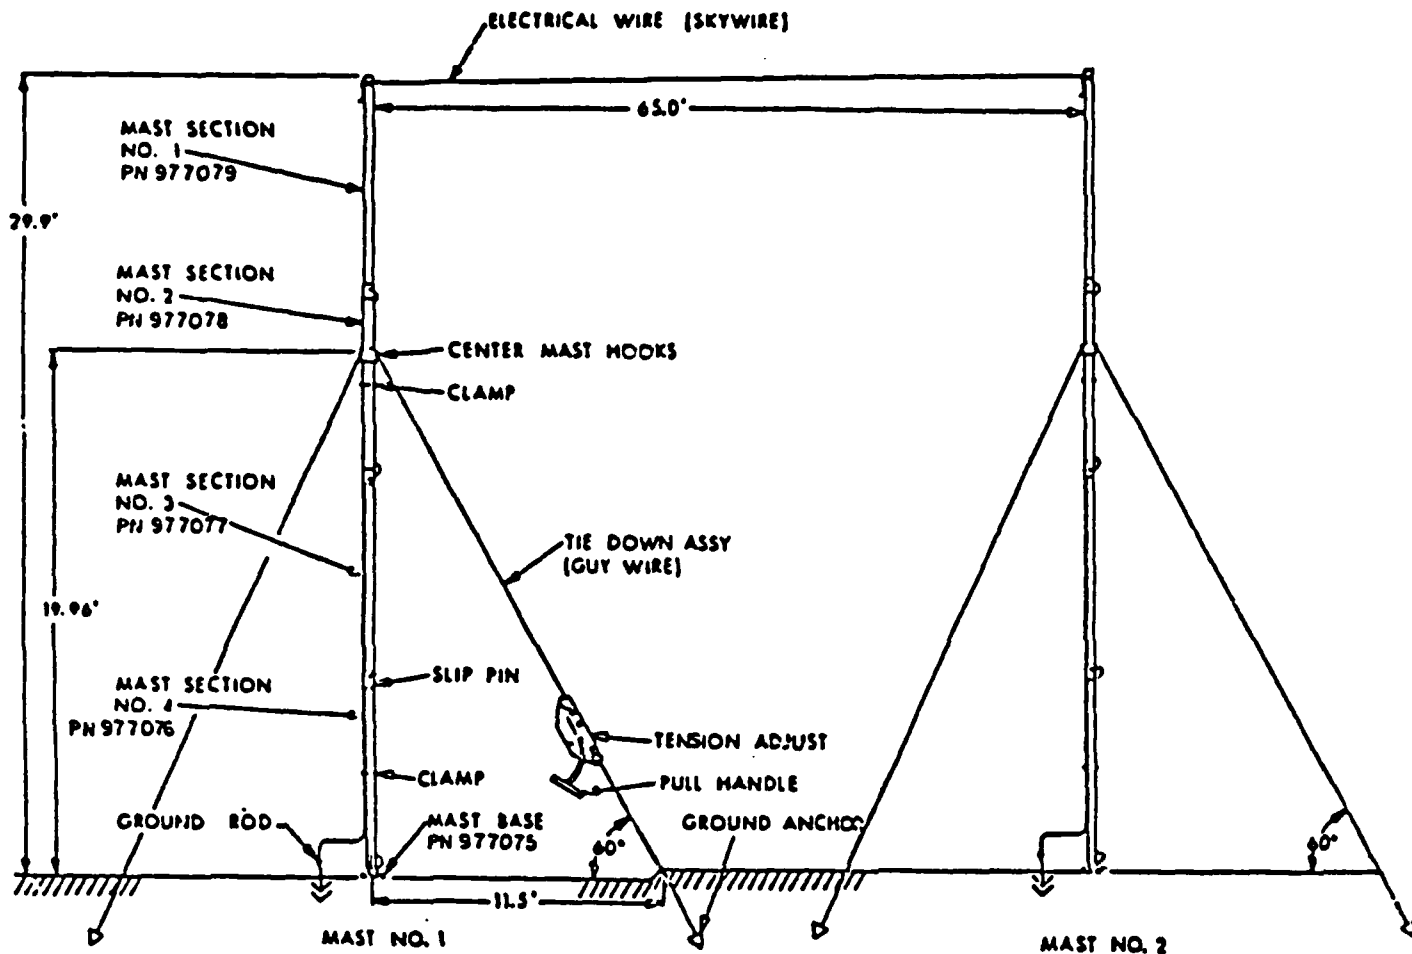
Figure 14. The lightning protection assembly (LPA) that was erected across the top of the antenna structures.

Implications: The LPA is erected next to the AN/TRC-170 antennas and shelter. The collapse of the mast might damage the antennas or shelter. The personnel are also endangered by a collapsing LPA mast.

Data: All the test participants (operators, supervisors, data collectors, and test directorate) recommended four-person crews for LPA erection/lowering tasks. Human Factors personnel observed 10 uncontrolled falls of the masts. In one case, an operator had the mast fall onto his shoulder causing a painful injury.

Potential Solutions: If the current LPA masts continue to be used, using a hinged base plate would make erection easier and safer, but for safety would require four man crews for erection. Alternately, consideration should be given to use of telescopic antenna mast sections which are already in the supply system. The training program should demonstrate correct erection/dis-assembly procedures to all 26QD6 personnel during specialty training.

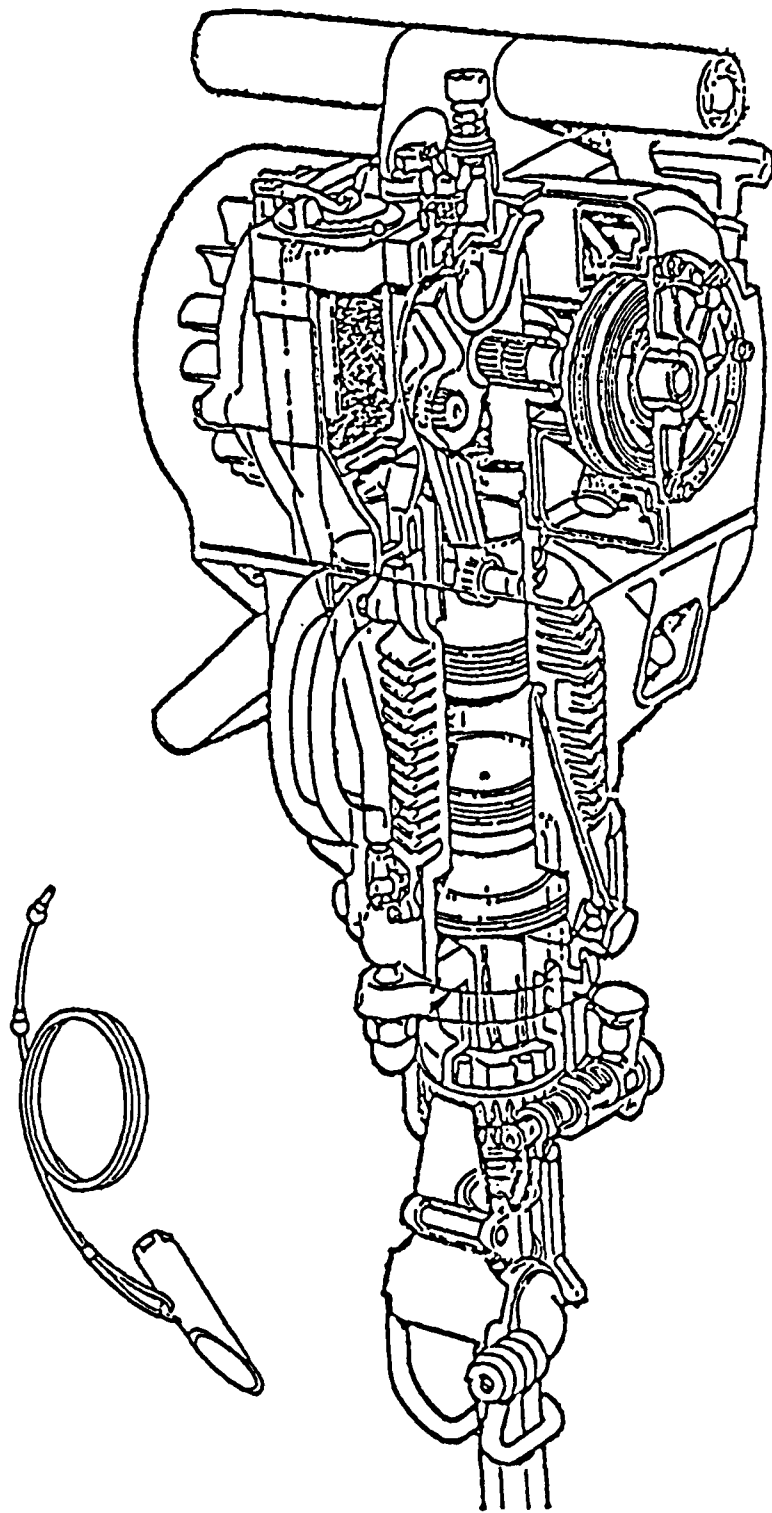
Figure 15. A cut-away view of the Pionjar drive motor and of the duckbill anchor.

Description of the Problem: Figure 15 shows a cut-away view of the Pionjar drive motor. Problems found on the non-militarized Pionjar included:

Data: Six Pionjars were unavailable due to maintenance problems during the test. The supply system issued improper oil for the oil and gas mixture that is required, causing some Pionjar failures. The crews in some distant sites had to obtain regular gasoline and 2-cycle motor oil from retail stores in order to operate the Pionjar.

Potential Solutions: A separate test of the Pionjar is needed. The device should also be required to meet military packaging and labeling standards. The logistics issue need review.

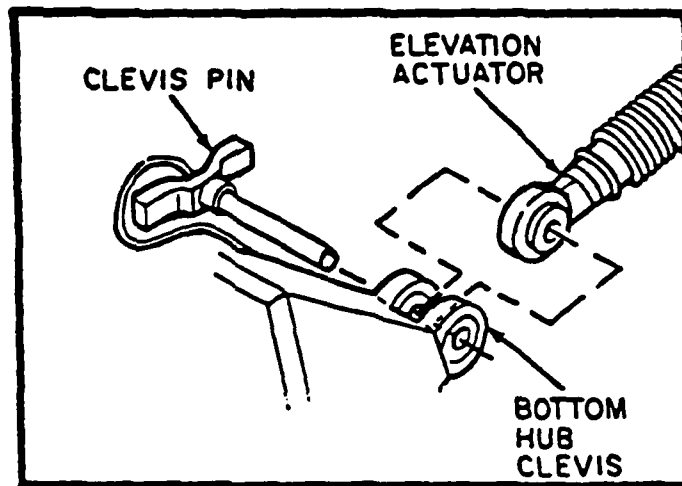
Figure 16. An example of the type of pin that was difficult to insert and remove.

Description of the Problem: Figure 16 shows the type of clevis pins used to secure and assemble equipment. The clevis attachment pins used on the AN/TRC-170 antennas are difficult to handle. The pins are used to hold the antennas together and to secure antenna parts to the low-profile pallet. The pins fit tightly and are difficult to install and remove. The pins have been damaged by attempts to install or remove them using improper tools such as hammers, rocks, and other objects.

Implications: The pins slow the assembly and disassembly process. There are no replacement pins supplied to the unit. Lost or damaged pins may make assembly or disassembly dangerous or impossible.

Data: Every unit had damaged pins. Replacing the pins was logistically difficult.

Potential Solutions: The pins should be treated with an approved lubricant to control corrosion and facilitate insertion. The holes receiving the pins should be flanged to help insertion/removal. Crewmen suggested that a rubber mallet be issued and used to insert or remove pins.

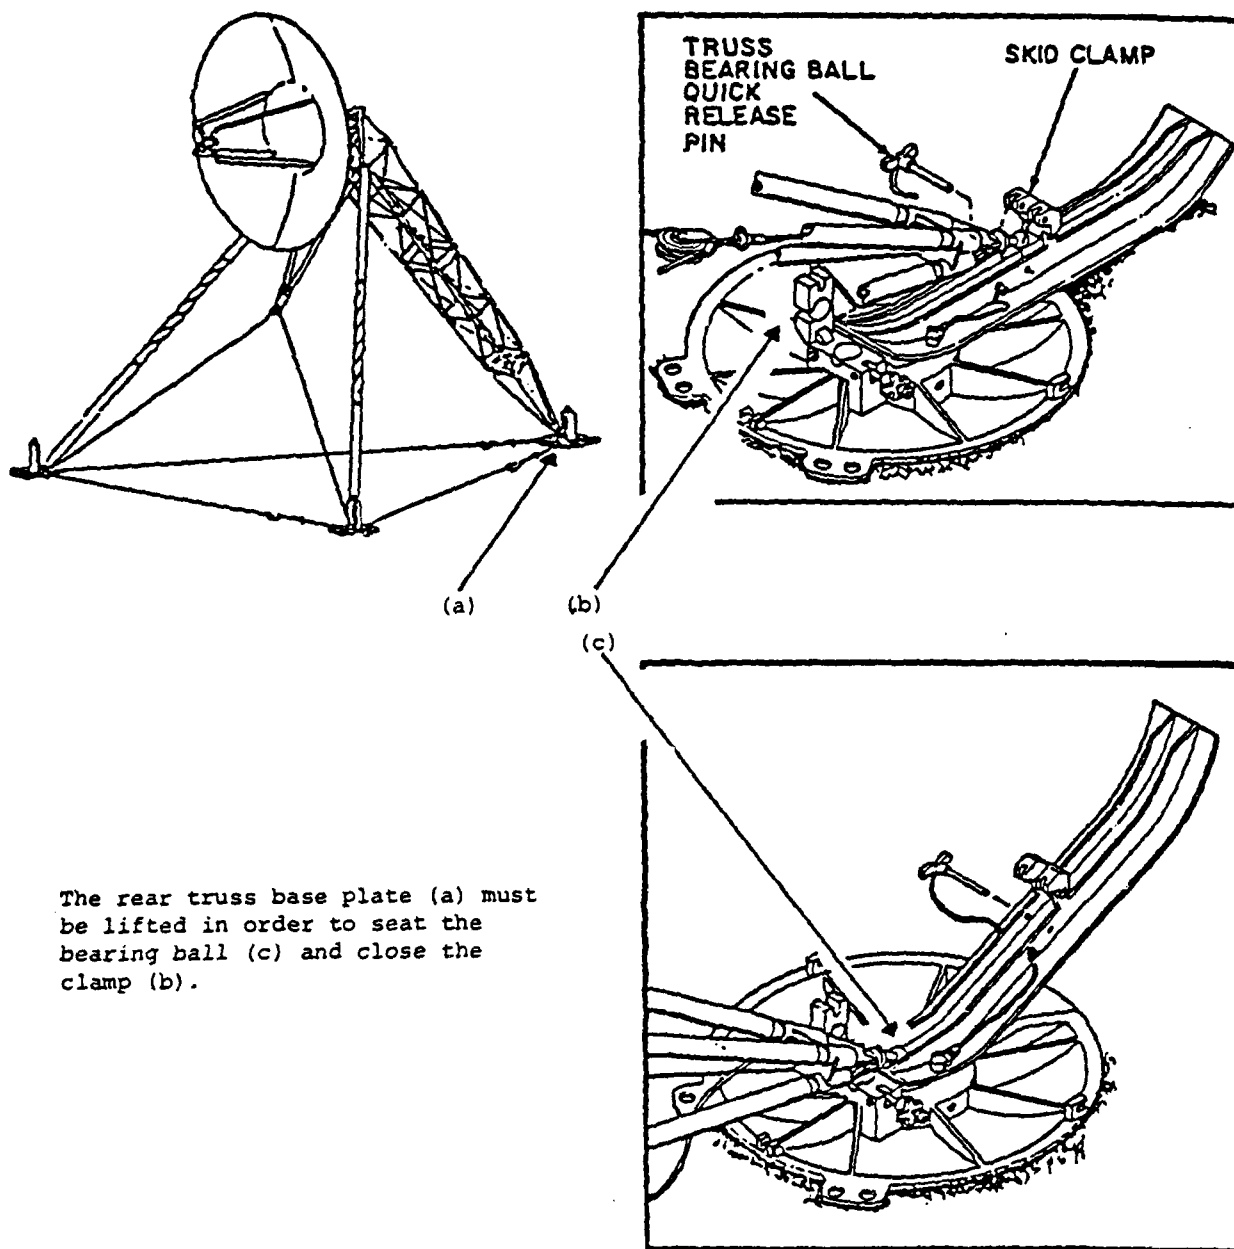
Figure 17. The 9.5-ft antenna (a), rear truss clamp (b), and bearing ball (c).

Implications: The operators may be injured an/or the antenna damaged. The rear truss might slip out of the base plate and fall. The antenna would become inoperable due to damage.

Data: The problem has been observed on 5 of the 12 antenna systems in test. The problem was not corrected on all the fielded antennas by the end of the test.

The rear truss base plate (a) must be lifted in order to seat the bearing ball (c) and close the clamp (b).

Potential Solutions: The rear clamp assembly needs to be modified. The new antennas in production should be modified prior to fielding.

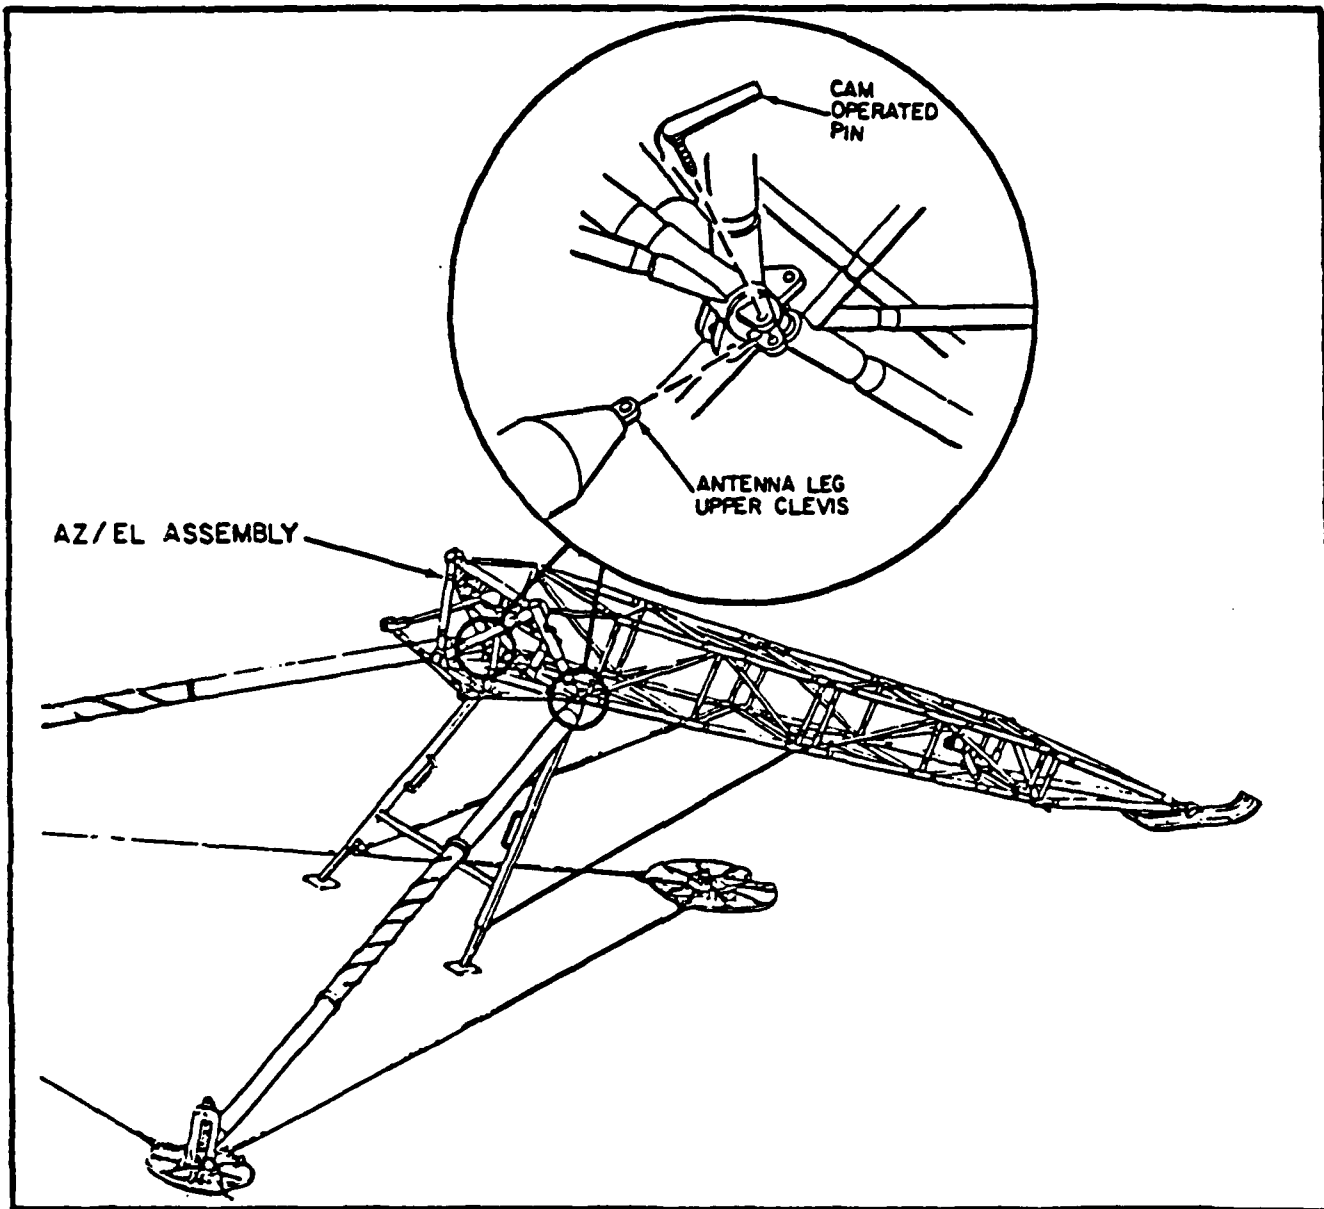
Data: Sixty-three percent (63%) of the operators reported observing personnel climbing or reaching in a dangerous manner. One operator broke his finger in the process of releasing the support struts for the AZ-EL assembly. Numerous reports were received concerning the dropping of antenna parts while crewmen were reaching and climbing.

Figure 18. An example of the type of manipulation task that could be performed more rapidly by crewmen using a stepladder or platform.

Potential Solutions: Provide a stand as standard equipment issue for the AN/TRC-170(V2). It is recommended that at least a 3-ft high stand or ladder be supplied.

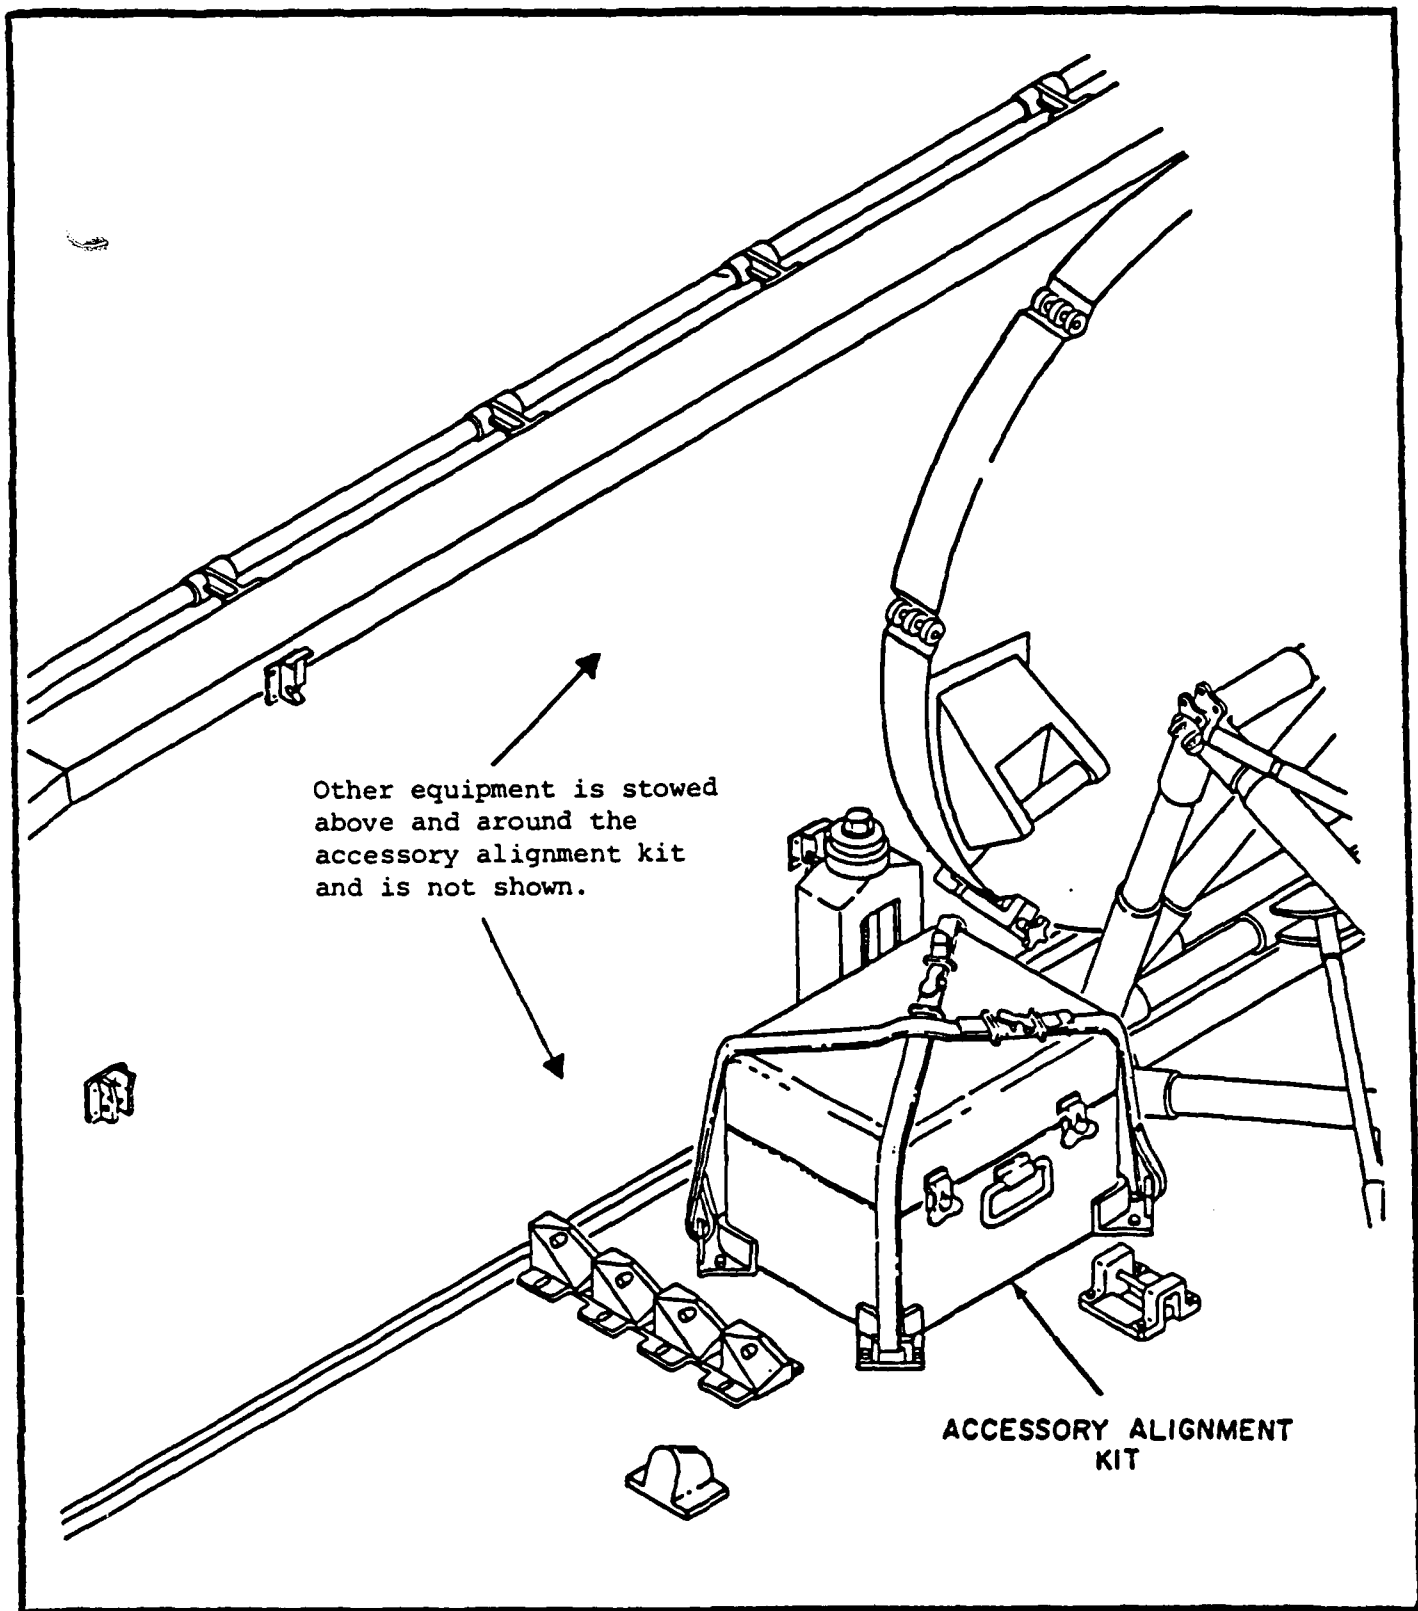
Data: Fifty-one percent (51%) of all the operators recommended that the location of the accessory kit be changed. Seventy-five percent (75%) of the crews moved the kit to either the truck cab or the shelter by the midpoint of the test without the direction of senior test participants.

Figure 20. The interior of the low-profile pallet showing the location of the accessory alignment kit.

Potential Solutions: The accessory kit should be placed in the shelter near the door or in the truck cab area for easy access.

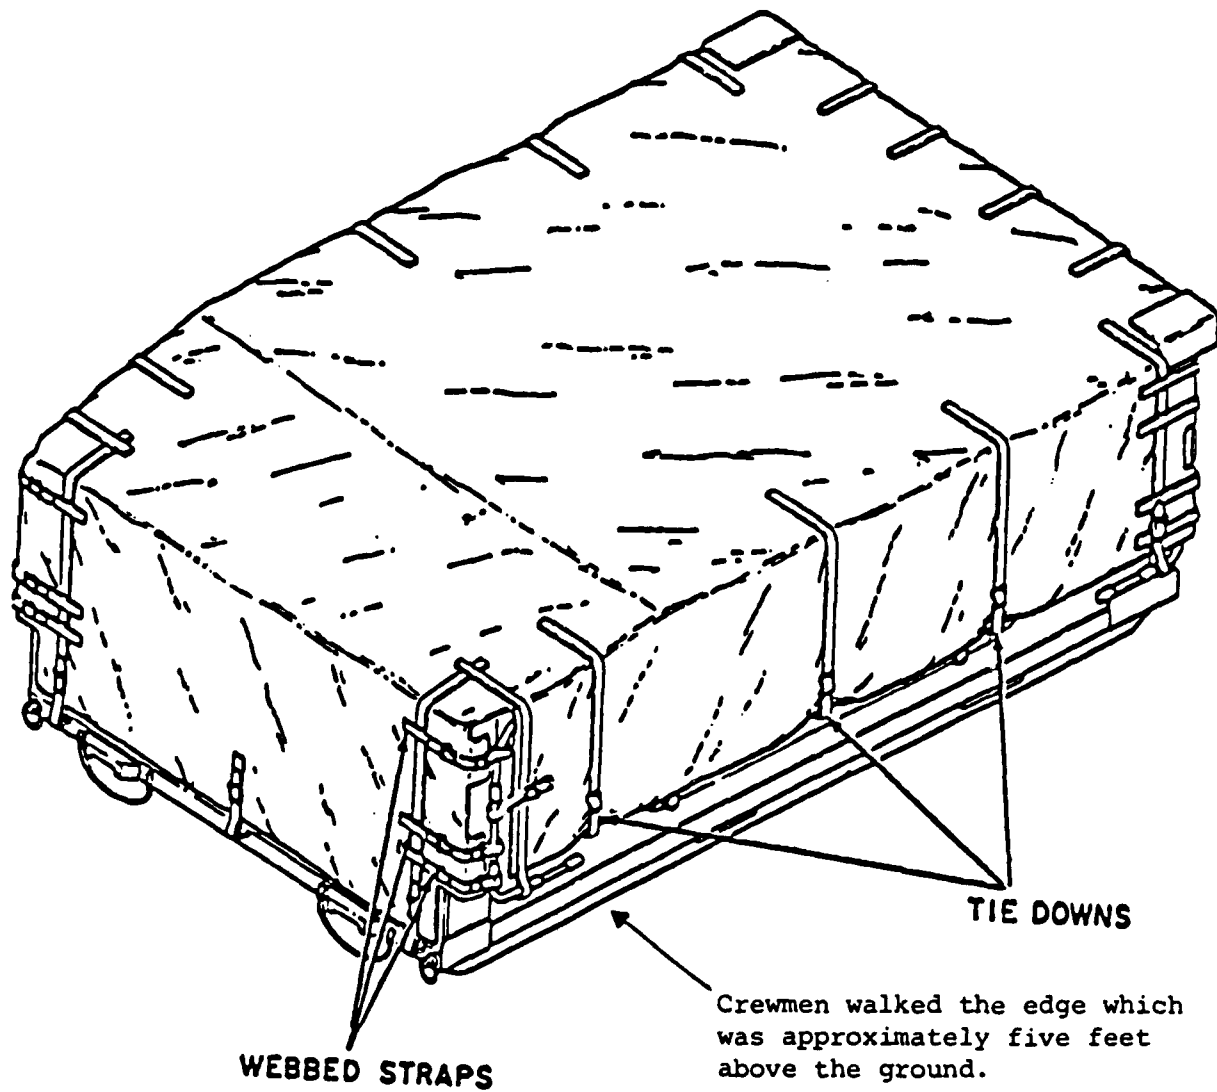
Figure 21. The low-profile pallet which was mounted on a 2.5-ton truck.

Data: Seventy percent (70%) of the crewmen reported that it was difficult for three crewmen to load and unload the low-profile pallet.

Potential Solutions: The canvas cover over the low-profile pallet could be provided with a drawstring arrangement so that personnel would not have to climb the side of the truck. The load on the low-profile pallet should be redistributed to facilitate loading and unloading, and consideration should be given to moving some of the load to the shelter.
